<b>Prüfbericht-Nr.:</b> <i>Test report no.:</i>	300100178.001	<b>Auftrags-Nr.:</b> <i>Order no.:</i>	3001 00178	Seite 1 von 25 Page 1 of 25
<b>Kunden-Referenz-Nr.:</b> <i>Client reference no.:</i>	2330545	<b>Auftragsdatum:</b> <i>Order date:</i>	08/04/2021	
<b>Auftraggeber:</b> <i>Client:</i>	Ennogie Aps, Orebygardvej 16, 7400 Herning, Denmark			
<b>Prüfgegenstand:</b> <i>Test item:</i>	Building integrated pitchroof installation kits			
<b>Bezeichnung / Typ-Nr.:</b> <i>Identification / Type no.:</i>	Ennogie Solardach, more details in the summary (clause 4) and photo appendix			
<b>Auftrags-Inhalt:</b> <i>Order content:</i>	Wind lift test following MCS 012			
<b>Prüfgrundlage:</b> <i>Test specification:</i>	EN 14437:2004 Determination of uplift resistance of installed clay or concrete tiles for roofing - Roof system method			
<b>Wareneingangsdatum:</b> <i>Date of sample receipt:</i>	15/03/2022, 26/08/2022	Detaillierte Fotodokumentation siehe Anlage zu diesem Bericht  Detailed photo documentation see appendix to this report

1	<b>Produktdetails</b> Product details	Ennogie Solardach (building integrated pitched roof PV mounting system)
2	<b>Verwendete Materialien</b> Used materials	N/

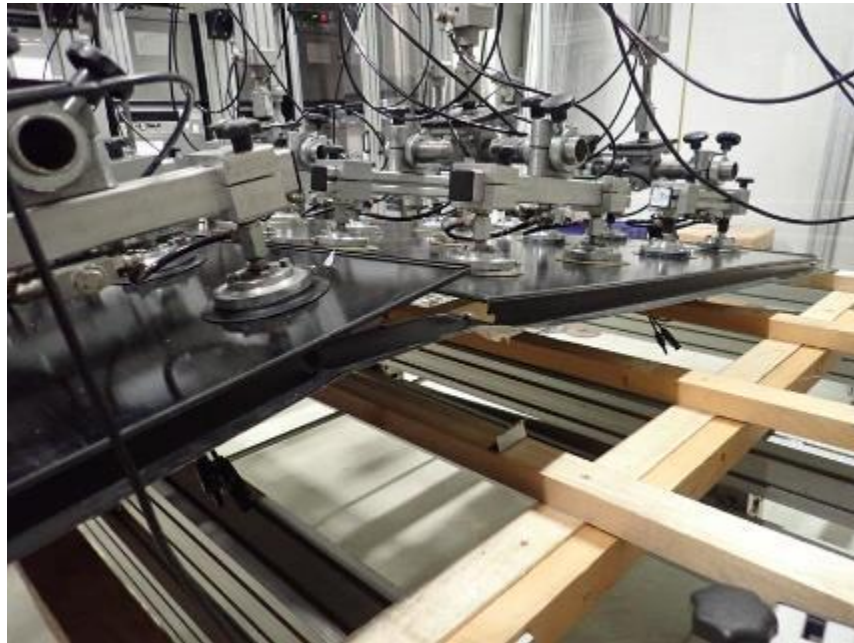
**Remark:** At 2850Pa in the middle between the two module rows all four mechanical fixings (mounting brackets), connecting the panels to the wooden substructure, were broken. Compare the photos attached.

Absatz Clause	Anforderungen - Prüfungen / Requirements - Tests	Messergebnisse – Bemerkungen / Measuring results - Remarks	Ergebnis Result
8.3	<b>Test results</b>		
	<p>In the first two tests the failure occurred at the same position of the mounting system. In both cases in the middle between the two module rows all four mechanical fixings (mounting brackets), connecting the panels to the wooden substructure, were broken. In the third test the adhesive between PV laminate (HV20220003206) and mounting rail detached.</p> <p>The failure tensile loads from Test 1, 2 and 3 are :</p> <ul style="list-style-type: none"> <li>• Test 1: 2750 Pa</li> <li>• Test 2: 2750 Pa</li> <li>• Test 3: 2500 Pa</li> <li>• The residual deflection did not exceed 5mm in any time.</li> <li>• The under pressure displacement did not reach the 75 mm in any time.</li> <li>• Failure pull out of metal components (partial factor 1.25)</li> </ul> <p>The characteristic mean wind uplift resistance will be calculated according to EN 14437:2004 as following:</p> $R_k = R_x - k_n s_x$ $R_x = \frac{1}{n} \sum R_i$ $s_x = \sqrt{\frac{1}{n-1} \sum (R_i - R_x)^2}$ <p>determined</p> <p>test</p> <p><math>R_x</math> is the mean uplift resistance</p> <p><math>s_x</math> is the standard deviation of the resistance</p> <p><math>k_n</math> is the statistical factor = 3.37 (for sample size of 3 from Table D.1 in EN 14437)</p> <p><math>R_i</math> is the individual measured value from each</p> <p>Partial factor    1.1 for failure metal components                      1.25 for failure by pull out of metal components                      1.44 for failure in timber or by pull out from timber components                      1.0 no failure, but the system exceed the limits of deviation</p>

Fig. 11: failure first test at 2750 Pa

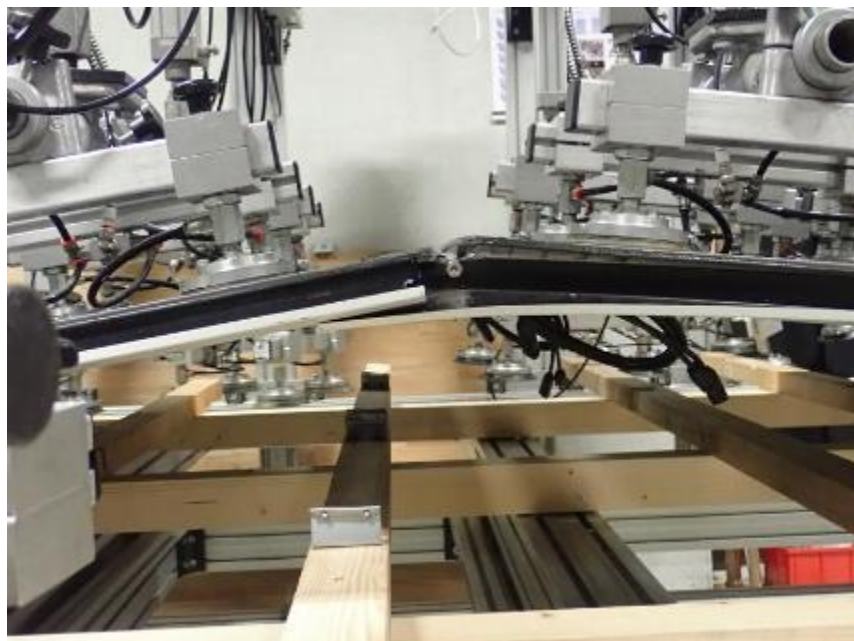
Fig. 12: failure first test at 2750 Pa

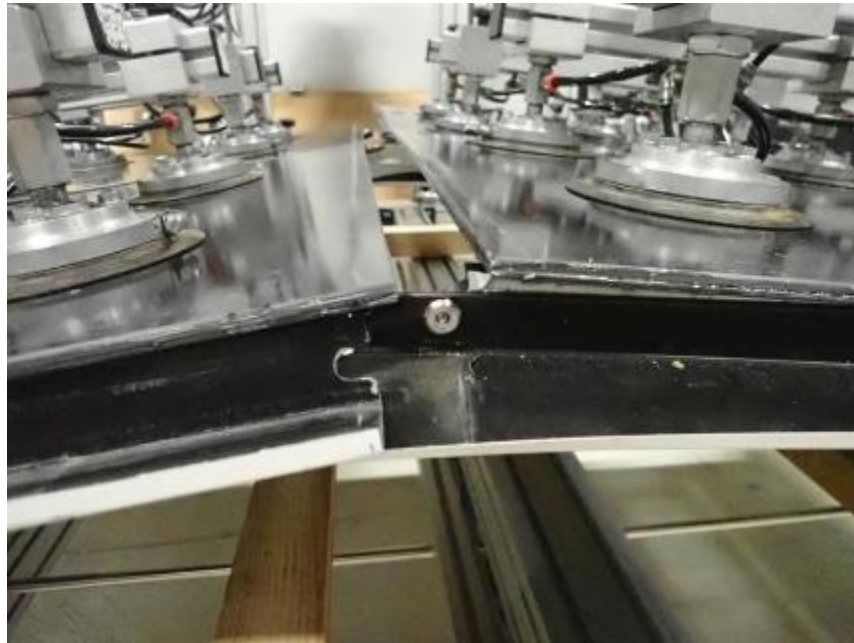
Fig. 13: failure first test at 2750 Pa

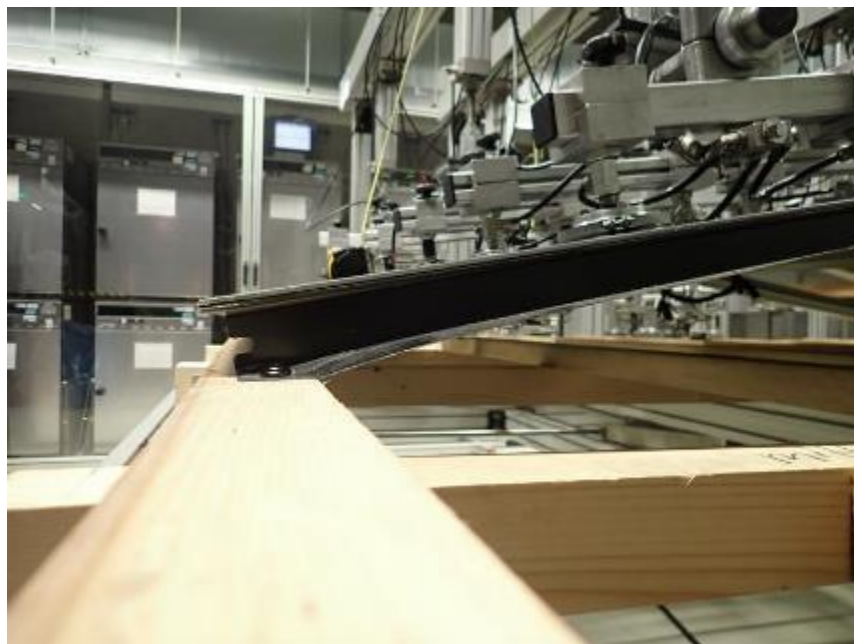
Fig. 14: failure first test at 2750 Pa

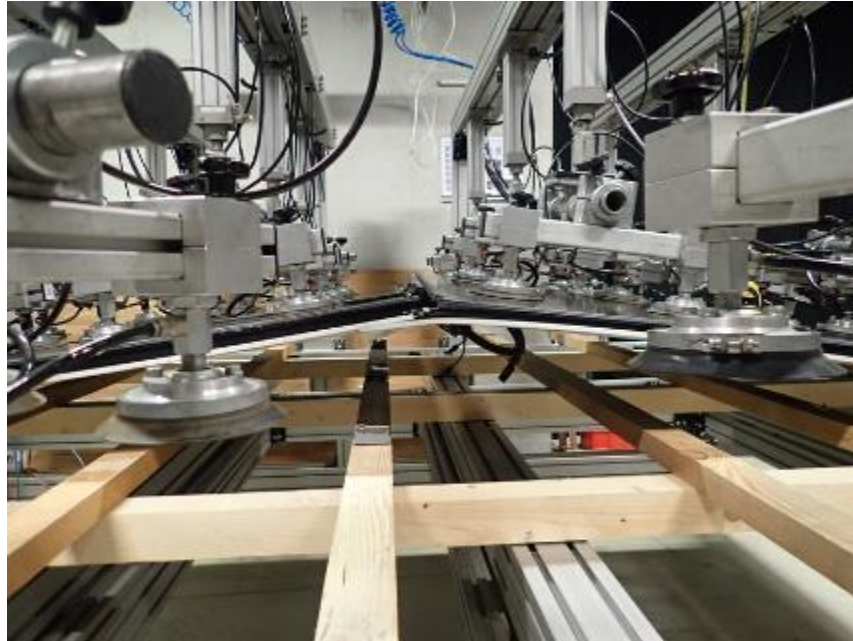
**Remark:** At 2850Pa in the middle between the two module rows all four mechanical fixings mounting brackets, connecting the panels to the wooden substructure, were broken. Compare the photos attached. PV panels and screws were replaced before starting the second cycle.

*Fig. 15: failure second test at 2750 Pa*

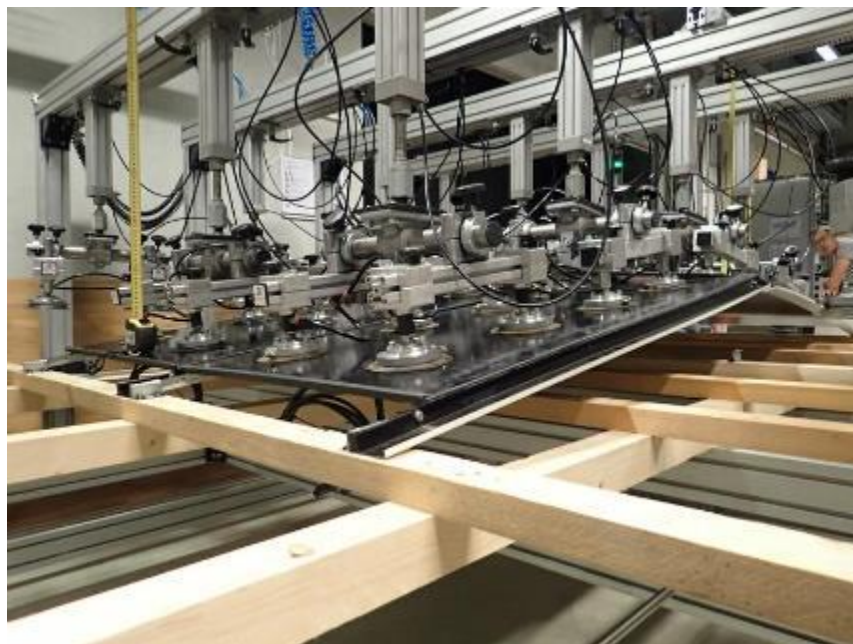
*Fig. 16: failure second test at 2750 Pa*

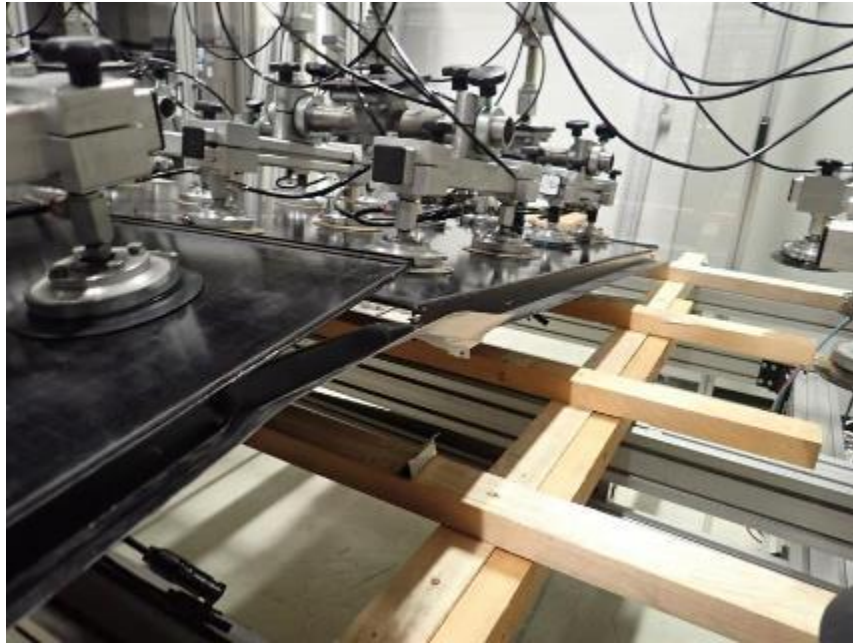
*Fig. 17: failure second test at 2750 Pa*

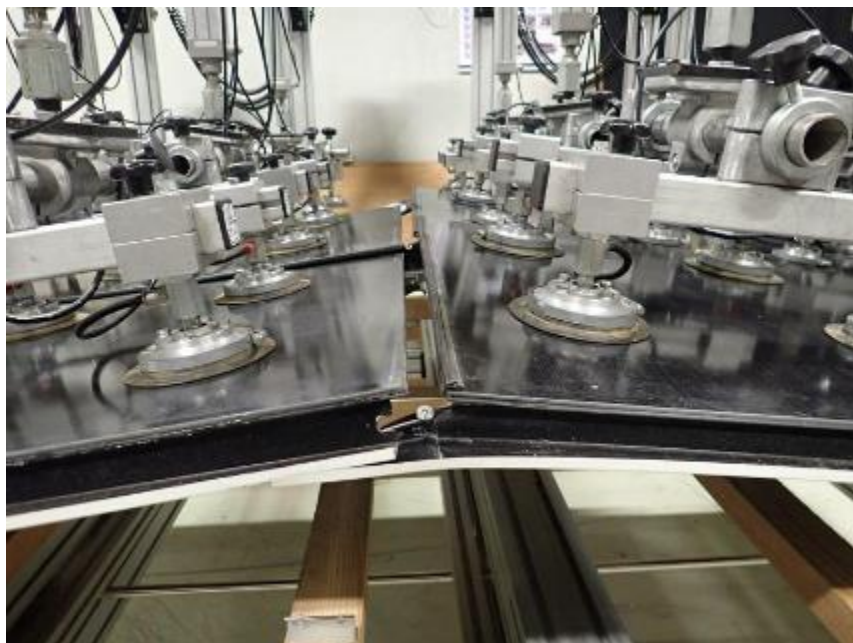
*Fig. 18: failure second test at 2750 Pa*

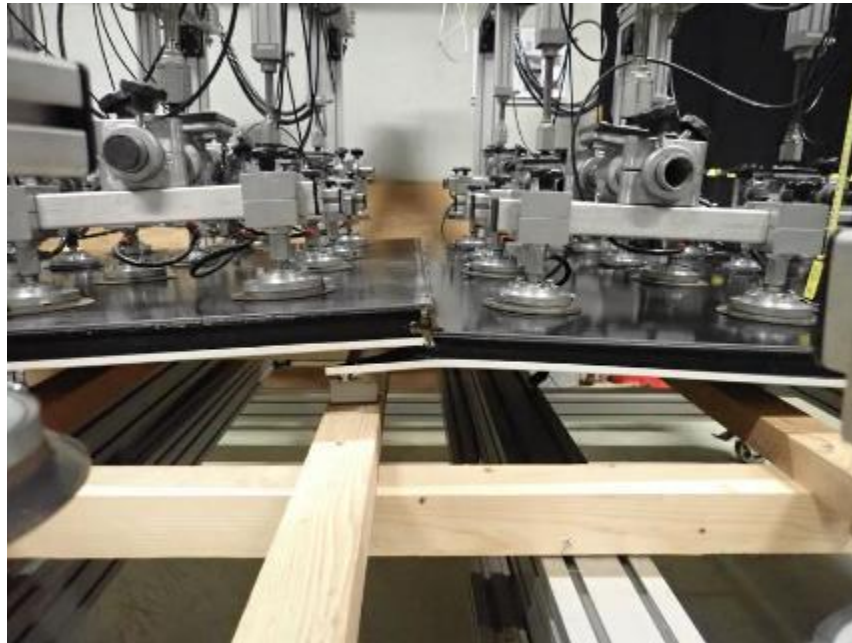
**Remark:** \*At 2750Pa the adhesive between PV laminate (HV20220003206) and mounting rail detached. Compare the photos attached. PV panels and screws were replaced before starting the third cycle.

Fig. 19: failure third test at 2500 Pa

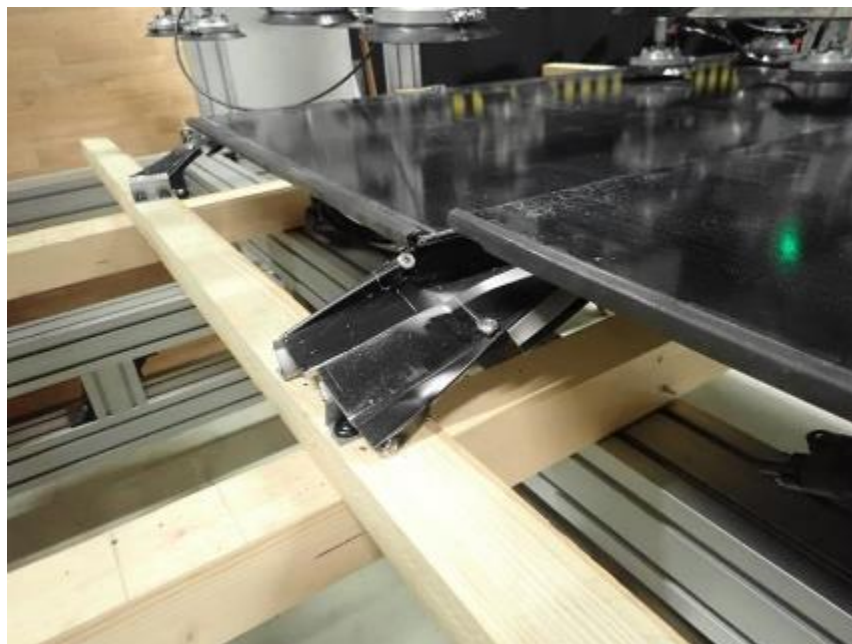
Fig. 20: failure third test at 2500 Pa

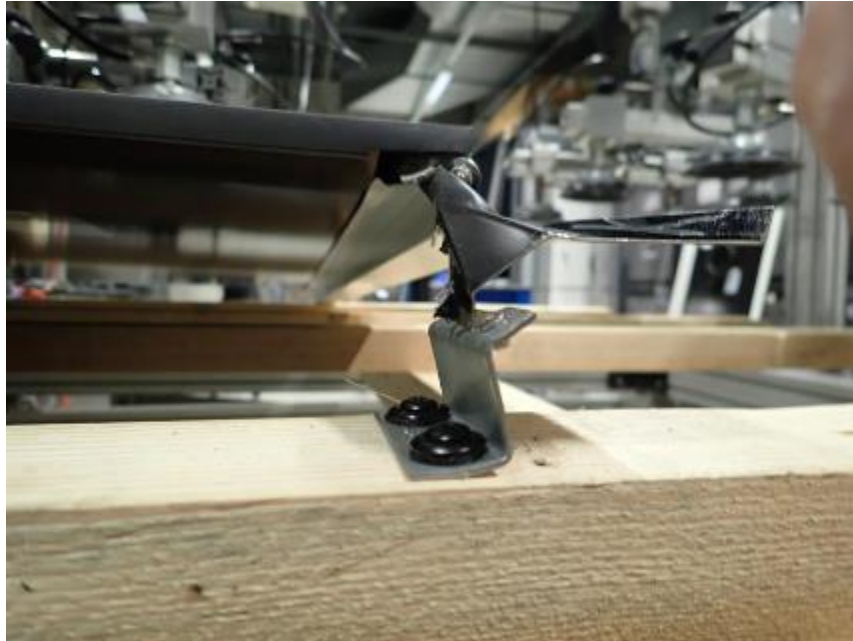
Fig. 21: failure third test at 2500 Pa

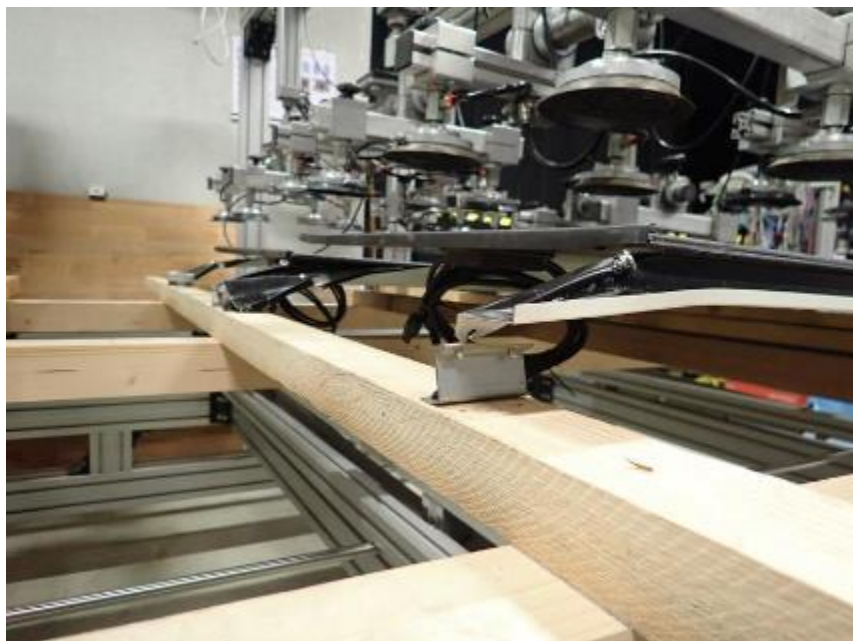
Fig. 22: failure third test at 2500 Pa
